# Manhole Inspection Summary

Manhole # S45W\_\_007MH

Insp Date: **3/13/09 10:14 AM**

**Location** Address: **1515 e clement st**

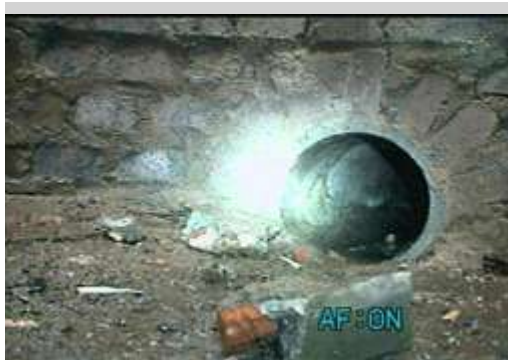
Miscellaneous

channel debris

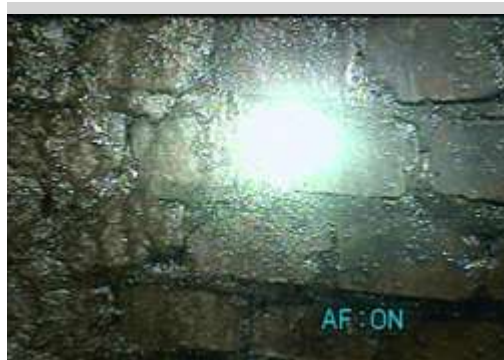
Defect 4

Infiltration: ☐ None ☐ Joint ☐ Cracks ☐ Mortar ☐ Roots ☒ **Wall**

infiltration from barrel wall

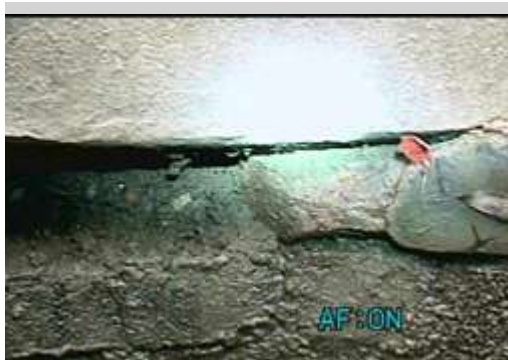
Defect 3

Condition: ☐ Sound ☐ Cracked ☐ Root Intrusion ☒ **Loose Brick** ☒ **Deteriorated**

chimney deteriorated with loose brick

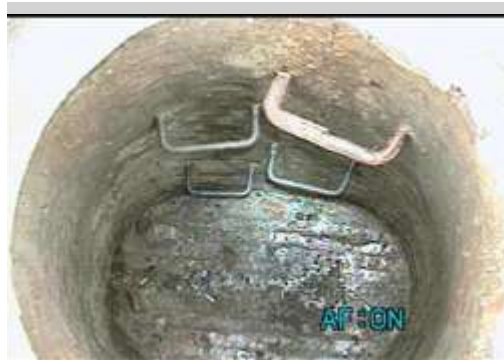
Defect 2

Count: **4** Missing: **0** ☒ **Corroded**

corr steps

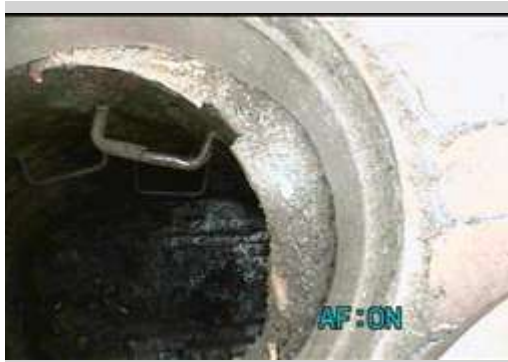
### Defect 1

Offset: **4** (in.)

frame offset

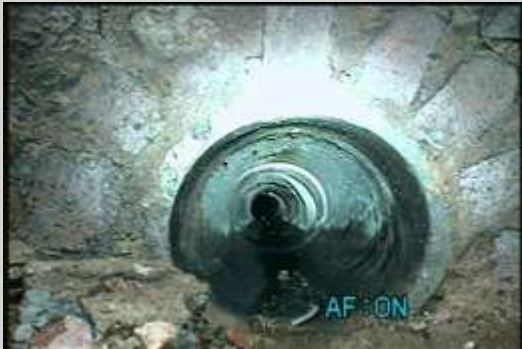
12 O'Clock Outflow

8 in. Circular Gravity Sewer  
Pipe Out @ 12 O'Clock
